**Report No. NA-70-23**  
**(DS-70-2)**

# **ACCELERATED TESTING OF GENERAL AVIATION ENGINE EXHAUST SYSTEMS**

**DEPARTMENT OF TRANSPORTATION  
FEDERAL AVIATION ADMINISTRATION  
National Aviation Facilities Experimental Center  
Atlantic City, New Jersey 08405**

Prepared by:  
GERALD SLUSHER

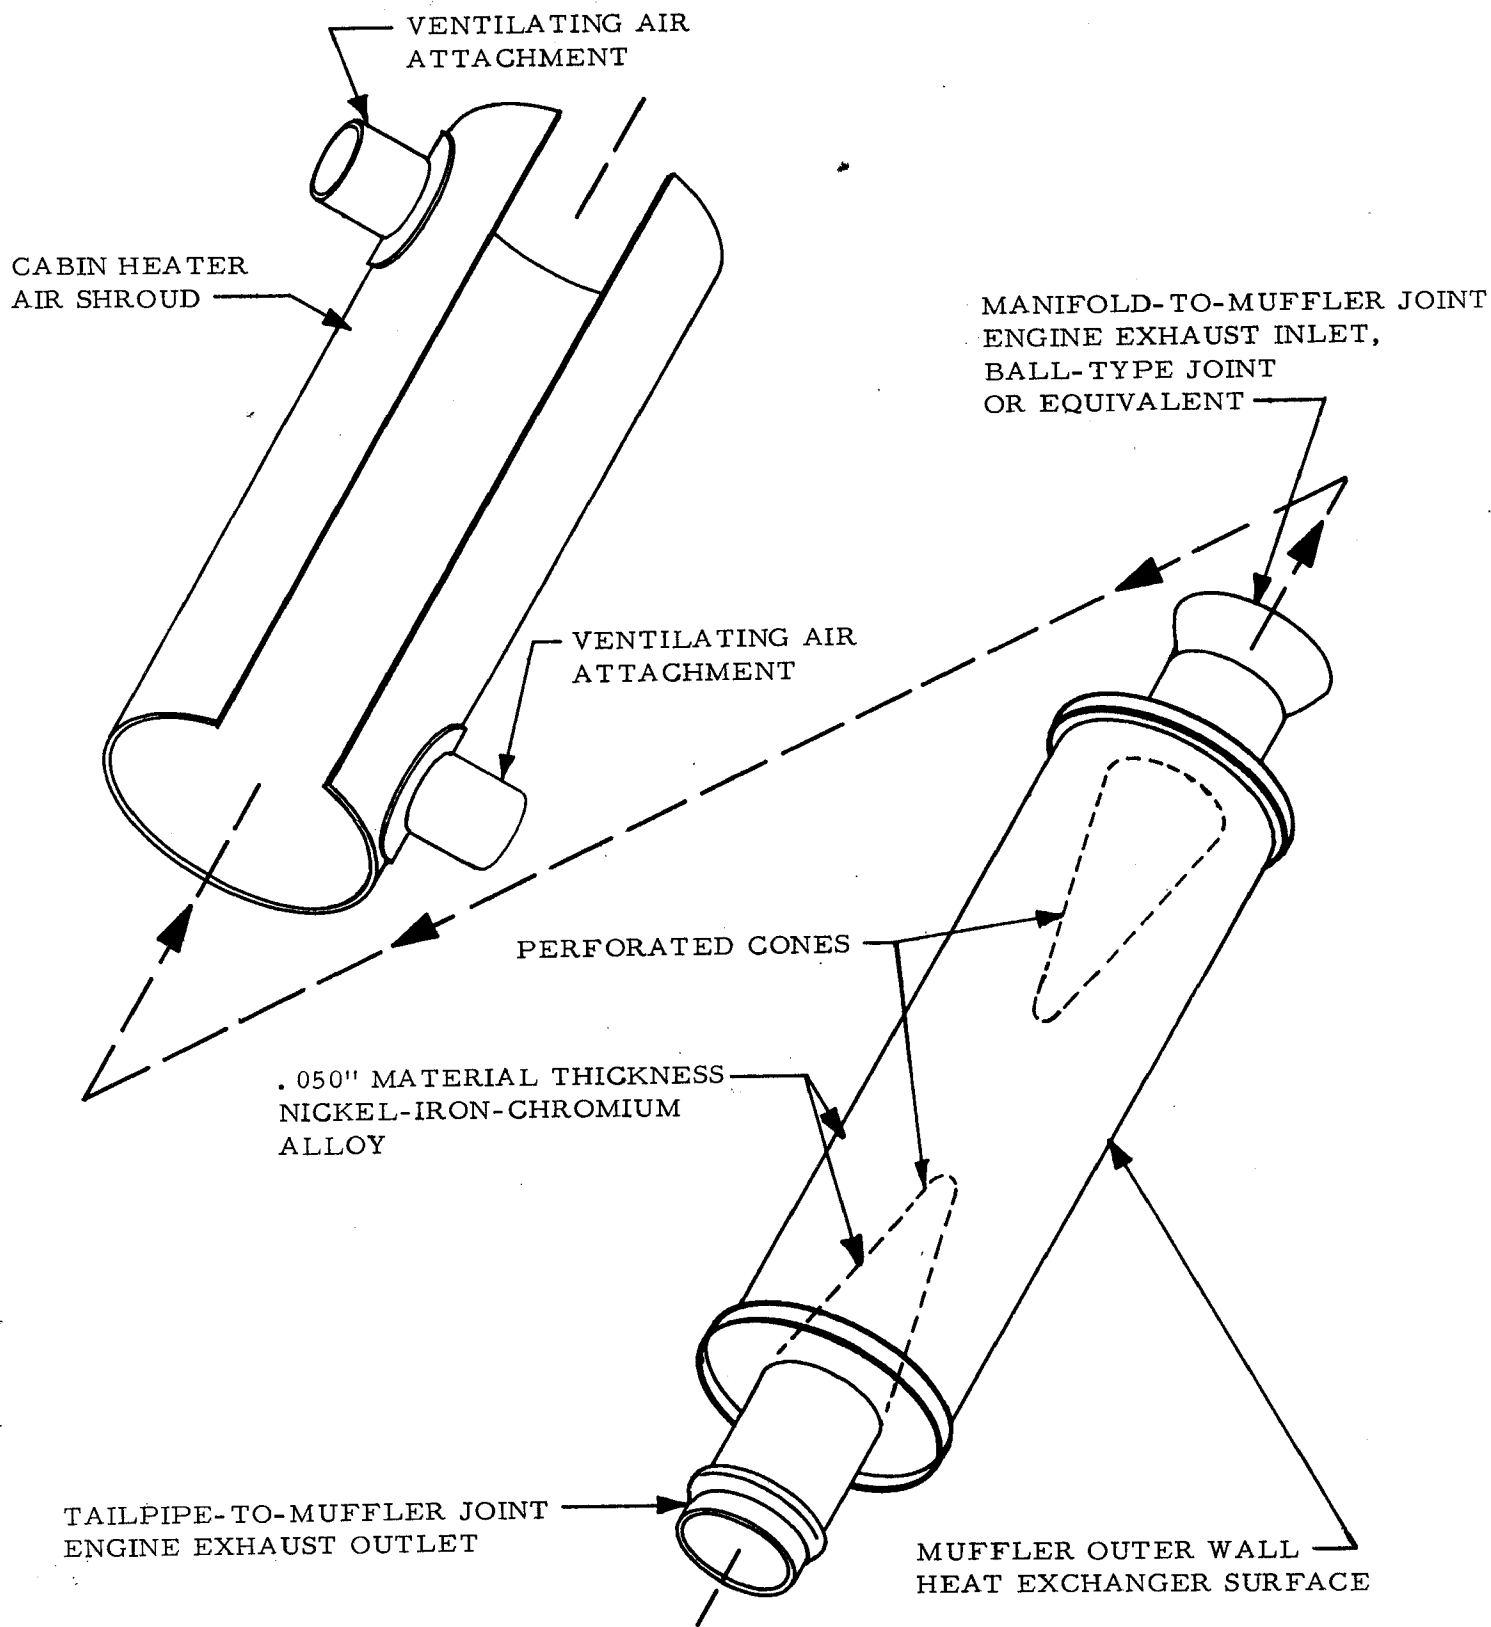
FIG. 4 RECOMMENDED MUFFLER AND HEAT EXCHANGER DESIGN

Cracks in the heat exchanger surface invariably occur in proximity to the stack inlet or tailpipe outlet attachments in areas of stress concentration. The carbon monoxide hazard could be reduced by excluding the areas of stress concentration from the heat exchanger surface. A recommended heat exchanger design, to minimize stress concentration in the heat exchanger, would incorporate an axial flow through muffler with the manifold inlet attached to one end plate and the tailpipe outlet attached to the opposite end plate as shown in Figure 4. The heater would be configured with an air shroud wrapped around the outer cylinder surface. A perforated cone welded to the end plate, at the tailpipe outlet location inside the muffler as shown in Figure 4, is suggested to prevent broken fragments from sealing off the exit area in the event of a failure. The muffler would be fabricated of a more corrosion-resistant alloy consisting of 32 percent nickel, 46 percent iron, and 21 percent chromium in material thickness of .050 inch.

6. Failures effecting carbon monoxide and engine power loss hazards can be significantly reduced by constructing airtight exhaust heater ventilating systems and incorporating muffler designs of the axial flow-through type of a more corrosion-resistant material .050 inch thick.

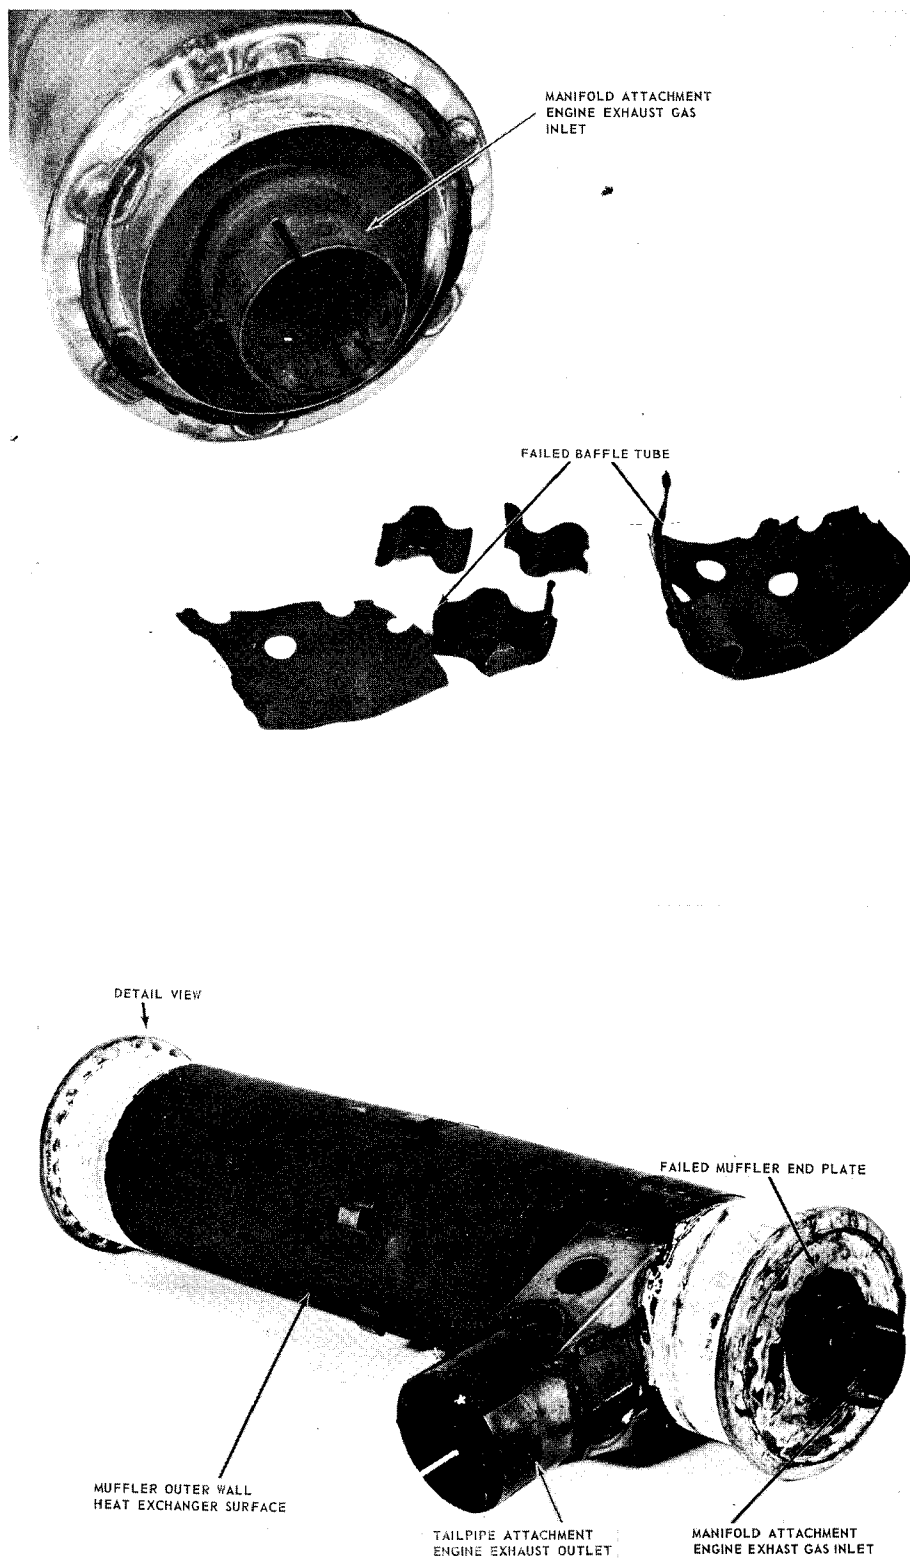
FIG. 1.1 FAILED MUFFLER BAFFLE TUBE AND END PLATES

Test Hours - 43: A muffler baffle tube and both muffler end plates failed at only 43 test hours as shown in Figures 1.1 and 1.2. A section from the floating end of the tube separated into pieces and passed through the tailpipe. In this instance, the fragments did not lodge in the muffler or tailpipe and restrict the exhaust gas flow and effect an engine power loss as often accompanies this malfunction in aircraft.

Metallurgical analysis of the baffle tube failure is discussed under the subheading of Sample No. 1, and the failure is shown in Figures 1, 2, 3, and 4 of Reference 5 in this report. As stated, "The entire sample was heavily oxidized and somewhat distorted. The end at which the failure occurred was severely oxidized and eroded." The part was fabricated from AISI 347 stainless steel .020 inch thick. High-temperature oxidation occurring on both sides weakened the baffle tube effecting a failure at low test time. Information in Reference 4 indicates that this part operates under temperature levels of 1500 F to 1600 F maximum. Numerous similar failures have occurred in operating aircraft.

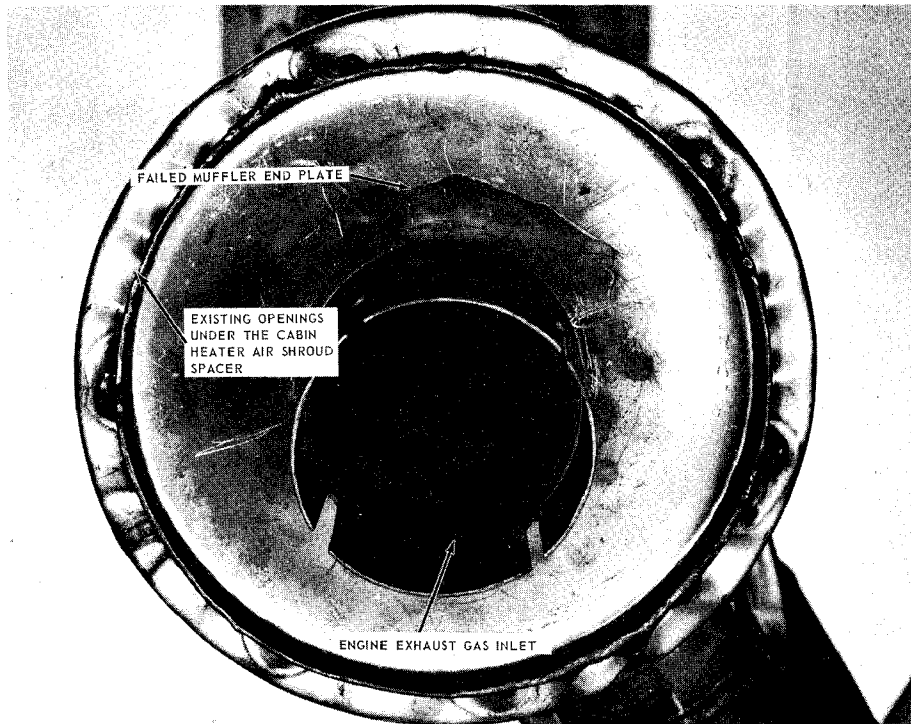
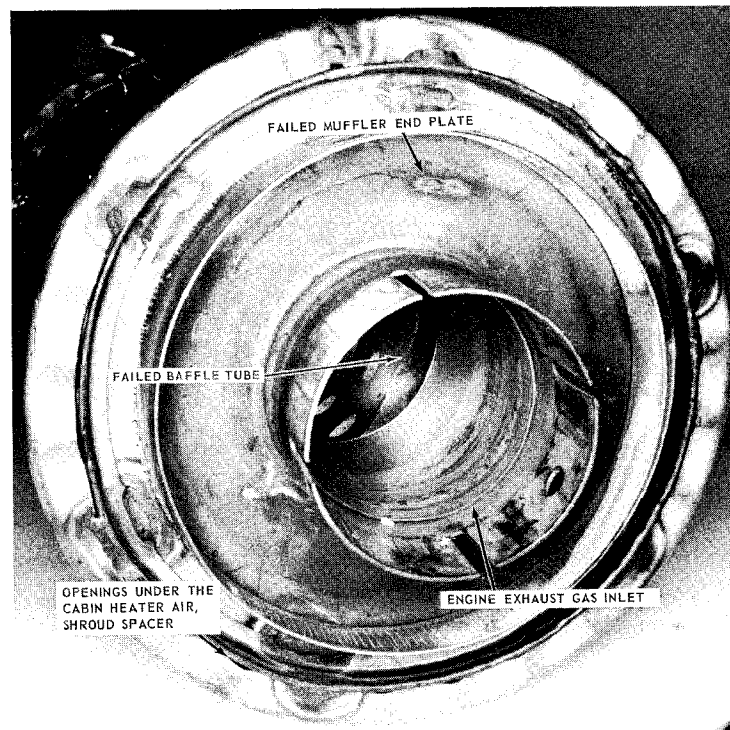
FIG. 1.2 FAILED MUFFLER END PLATES AND BAFFLE TUBE

Failure of the end plates of the muffler is discussed under the subheadings of Samples Nos. 2 and 3, and depicted in Figures 5 through 13 of Reference 5. There was not an apparent metallurgical cause for failure noted. The most likely cause was believed to be high stresses induced by high-intensity vibration occurring after the baffle tube failure. Upon failure, the remaining portion of the tube was no longer supported from the floating end. A 19-inch section of the tube was then cantilevered from the end plate of the muffler effecting a severe vibration problem and high stresses.

A carbon monoxide hazard was effected by failure of the muffler end plates. Exhaust gases containing carbon monoxide exited through the fracture in the end plates and entered the cabin heater through the existing openings under the cabin heater air shroud and contaminated the cabin air with .010 percent carbon monoxide.

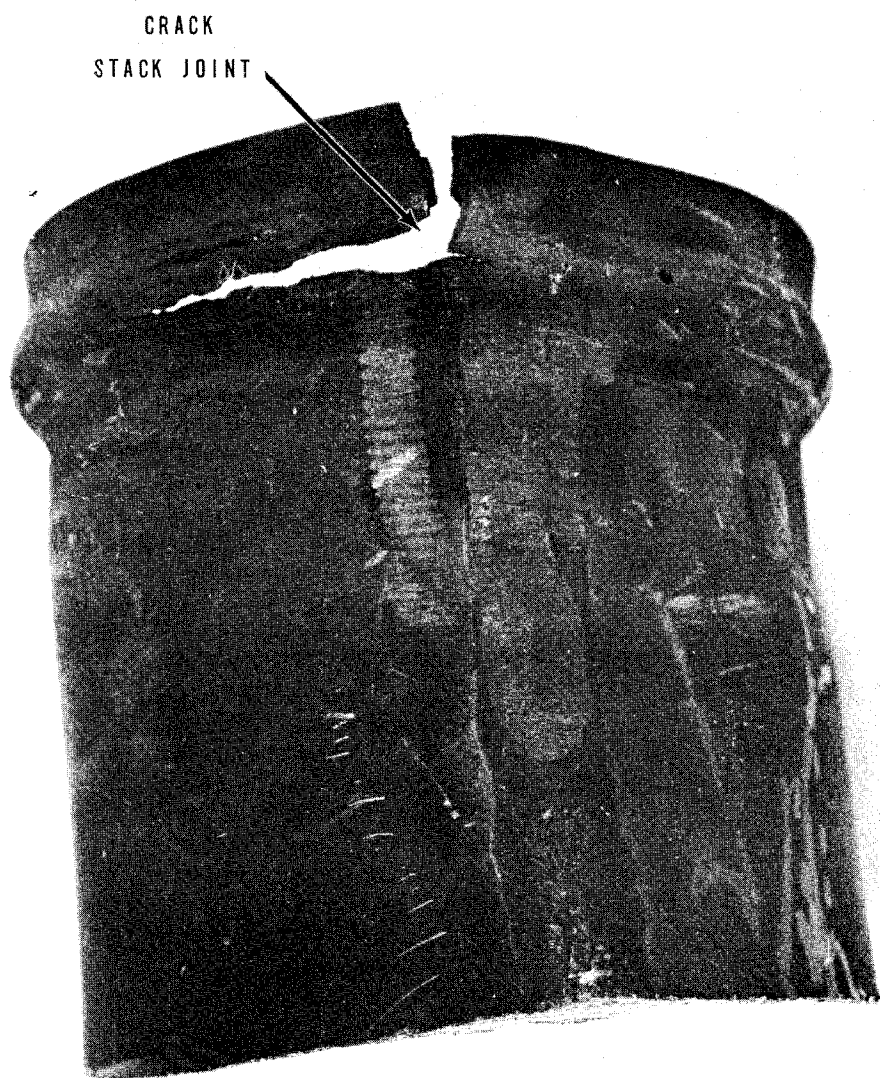
FIG. 1.3 FAILED STACK JOINT

Test Hours - 112 and 140: Two similar cracks occurred in the stack joints as shown in Figure 1.3. The failed stack was replaced with an identical unit which also failed. The crack occurred in the swaged ferrule utilized for clamping and locking the joint and extended out

through the welded seam of the pipe. Metallurgical evaluation of the defect is discussed under the subheading of Sample No. 8, and the failure is presented in Figures 29 through 33 of Reference 5. As stated, "The Metallographic examination of the cross section of the crack revealed heavy oxidation on the surfaces on either side of the crack. This is a strong indication of the progressive nature of the crack since oxidation occurred on the fracture surface as the crack progressed. The fact that there is no thinning of the metal at the fracture also suggests that it is a type of fatigue crack. Slip bands are typical of a condition created at the tip of a fatigue crack."

After the second failure occurred, the manufacturer submitted a stack incorporating a modified joint which accumulated 350 test hours without failure. This part was fabricated from AISI 321 stainless steel .050 inch thick and operates at metal temperature levels up to 1200°F. (See Reference 4.)

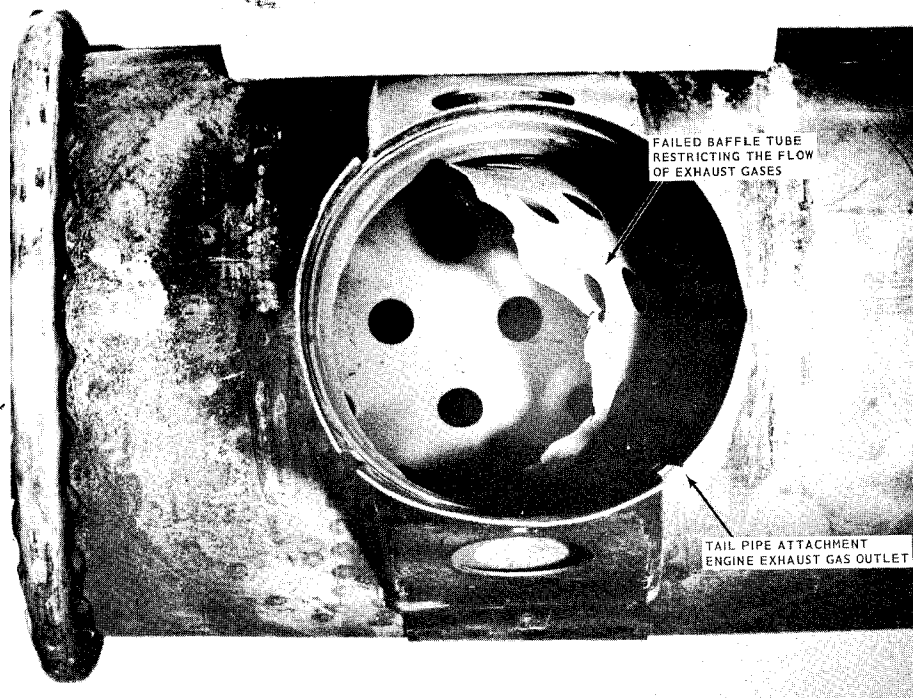
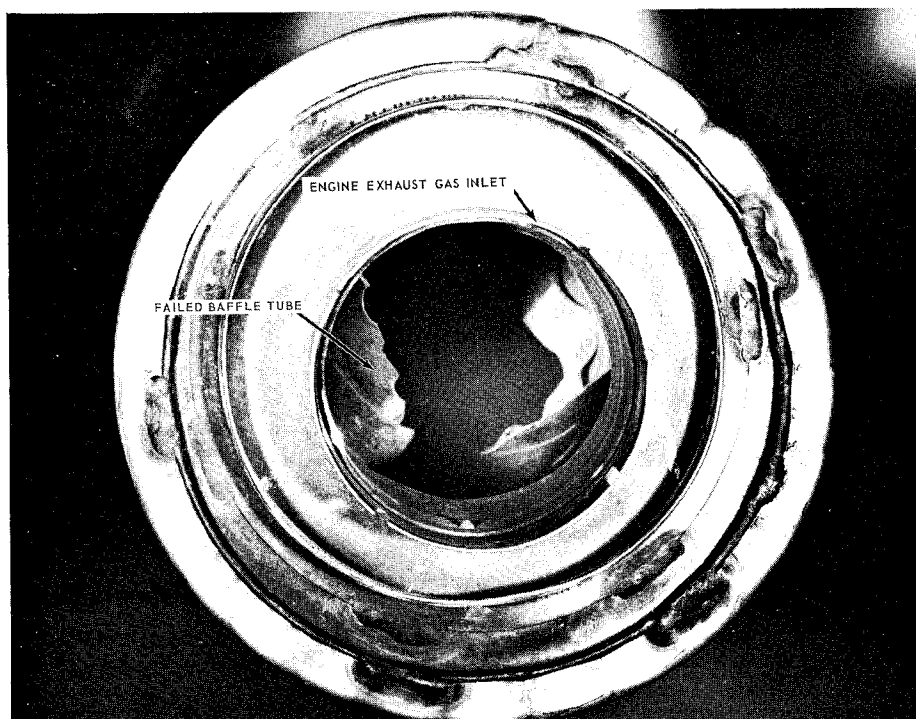
FIG. 1.5 FAILED MUFFLER BAFFLE TUBE

Test Hours - 160: A muffler baffle tube failed at 160 test hours effecting an engine power loss. A section of the baffle lodged in the muffler tailpipe outlet restricting the flow of exhaust gases as shown in Figure 1.5. Metallographic examination of this failure is analyzed under subheadings, Samples Nos. 4 and 5, and the failure is shown in Figures 14 through 19 of Reference 5. As stated, "The baffle exhibited severe oxidation and distorted edges at the failed area." This part was also fabricated from AISI 347 stainless steel material stock .020 inch thick. The basic failure was identical to the one occurring at 43 test hours discussed previously in this report. The baffle tube operates under maximum temperature levels of 1500°F to 1600 F. (See Reference 4.)

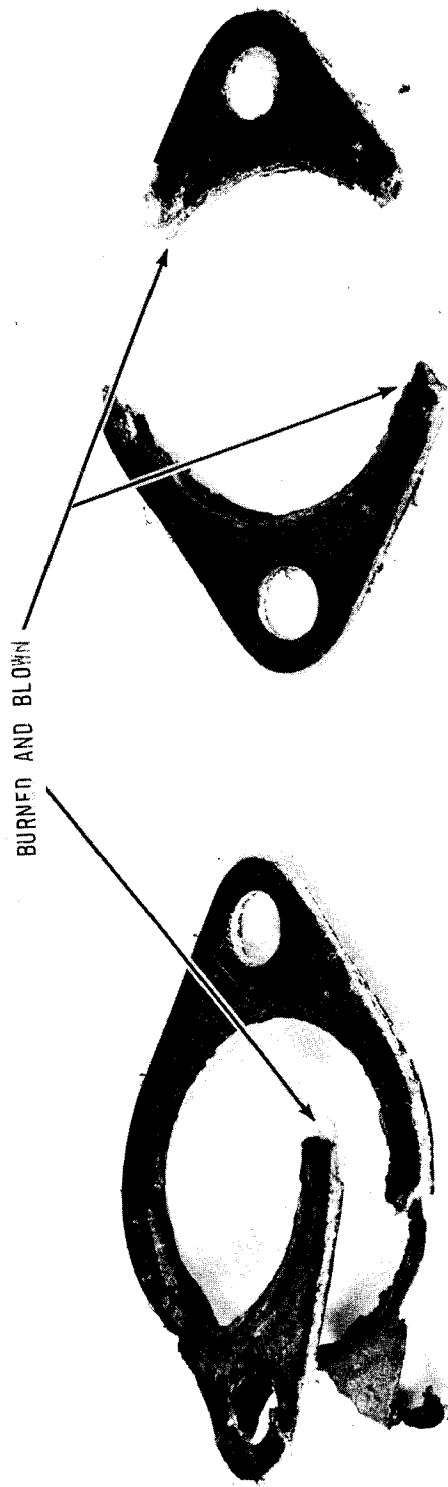
FIG. 1.6 FAILED ENGINE EXHAUST FLANGE GASKETS

Test Hours - 305, 346, 400, and 525: The exhaust gaskets burned through at the above listed test hours as shown in Figure 1.6. Gasket failures permitted exhaust gases to contaminate the engine nacelle and resulted in seepage into the cabin through openings in the heater ventilating air system. In two incidents, the aluminum retaining parts melted and failed to retain the seal composed of fiberglass. Exhaust gases exiting through the blown gaskets entered the heater seal openings and contaminated the cabin air with .0025 percent carbon monoxide. Also, two cases of blown exhaust gaskets resulted in traces of carbon monoxide in the cabin air when exhaust gases entered existing openings under the cabin heater air shroud. Exhaust gas from blown gaskets is diluted with cooling air in the nacelle and usually seeps into the cabin at concentrations less than the limit of .005 percent considered hazardous by the Federal Aviation Administration.

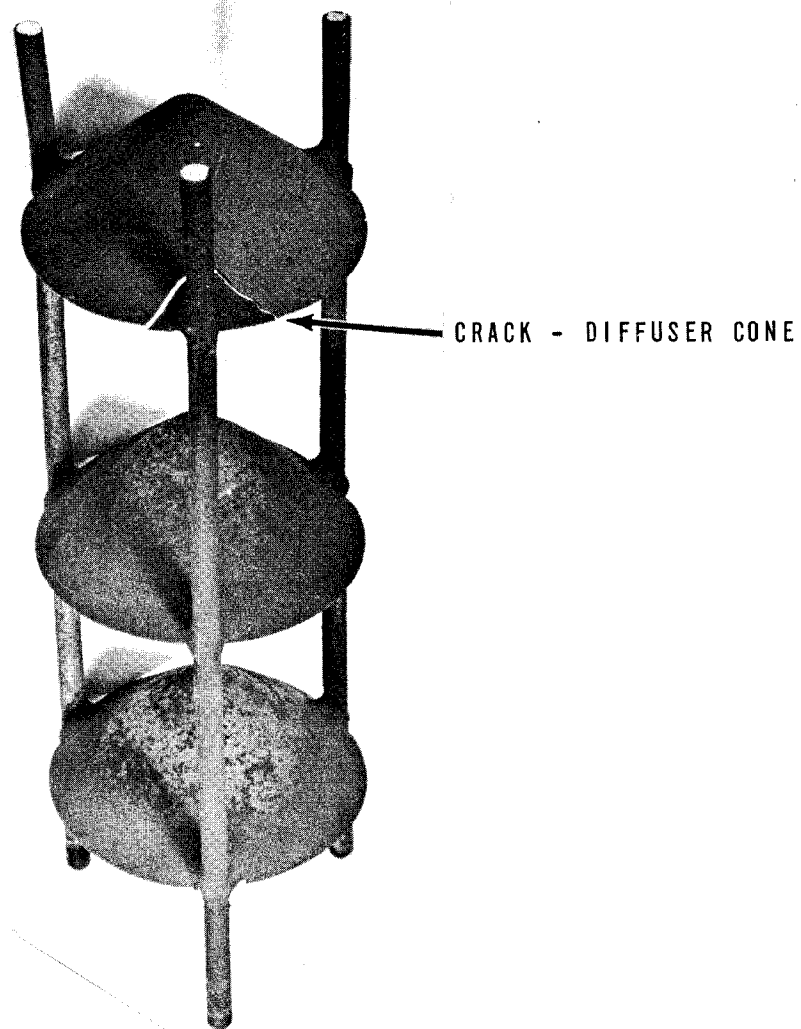
FIG. 1.7 FAILED MUFFLER DIFFUSER CONE

Test Hours - 440: A fracture occurred in a muffler diffuser cone as depicted in Figure 1.7. The part was fabricated from AISI 321 stainless steel .050 inch thick. Metallurgical evaluation of this part is located under the subheadings of Samples Nos. 10 and 11, and the part is shown in Figures 41 through 45 of Reference 5. As stated, "All of the cones were heavily oxidized on the lower surface. The failed cone showed little, if any, evidence of oxidation on the upper surface. Examination of the microstructure revealed a substantial amount of sigma phase in the grain boundaries and some within the grains." It was determined from Reference 4 that this part operates under maximum temperature levels of 1500°F to 1600°F.

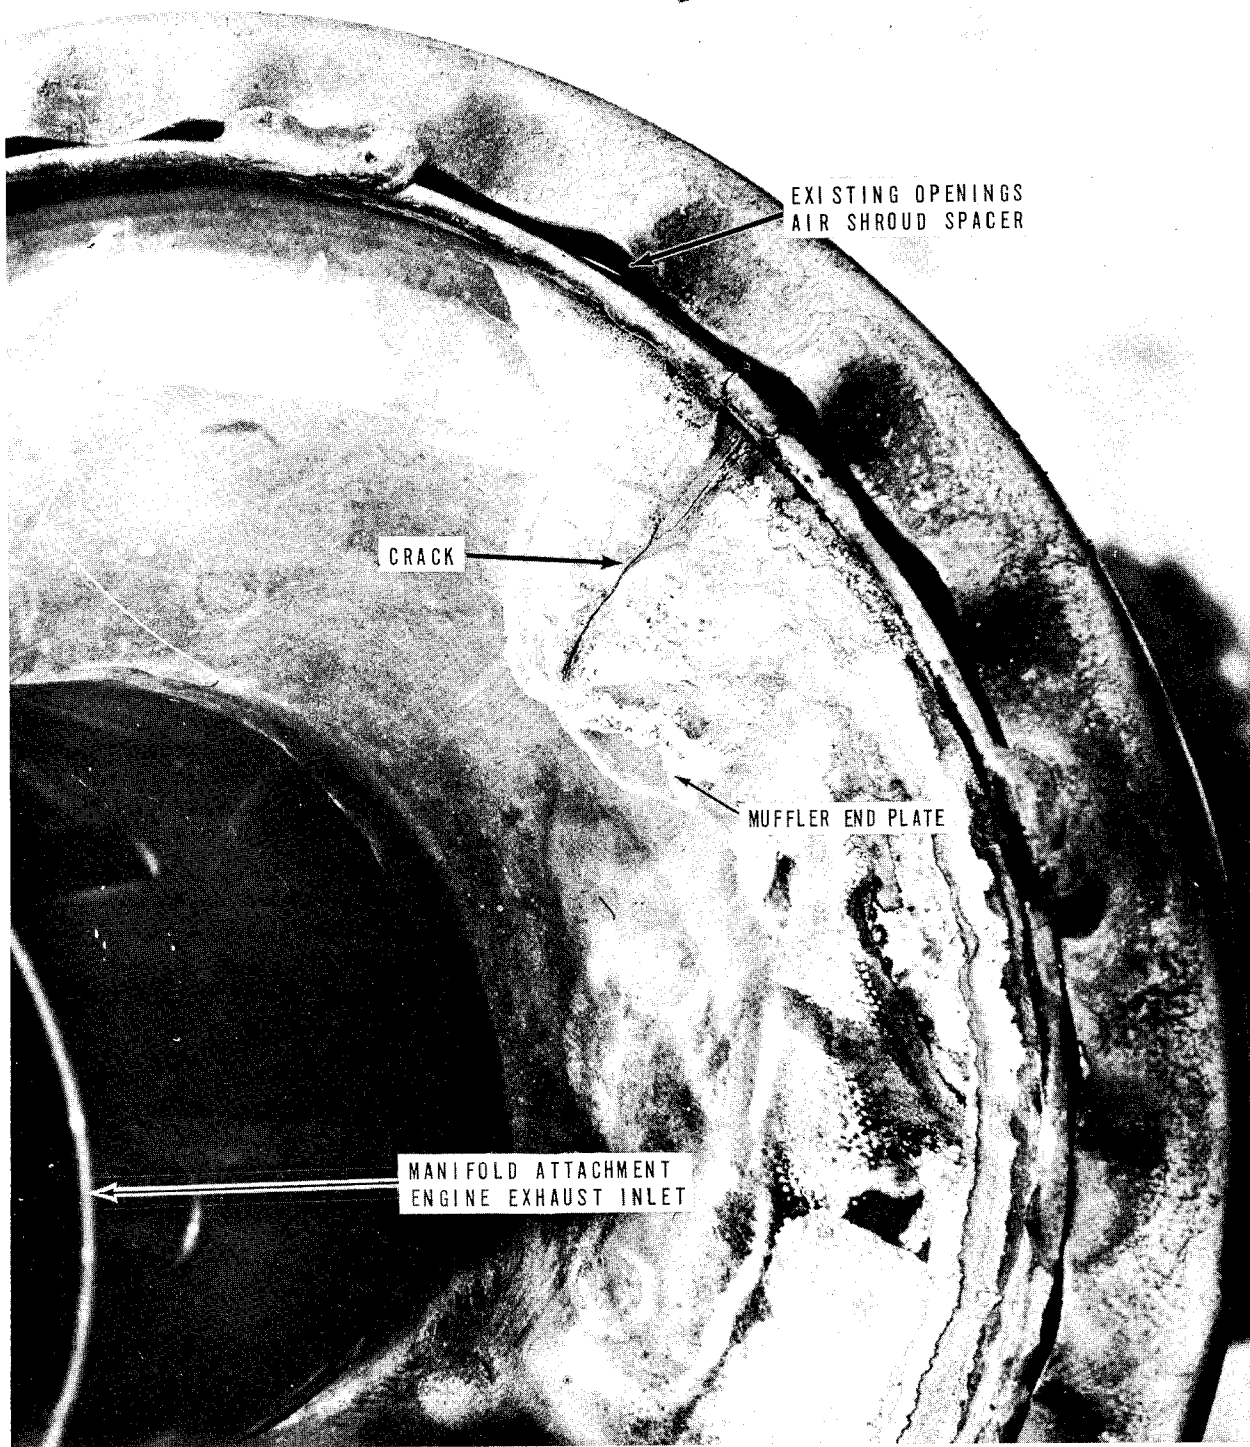
FIG. 1.8 FAILED MUFFLER END PLATE

Test Hours - 448: A crack occurred along the radius of a muffler end plate at 448 test hours as shown in Figure 1.8. Three of four rivets joining the baffle tube to the end plate intake tube were completely sheared and the fourth, while still intact, was cracked and weakened by loss of material. This is shown in Figure 1.9. Metallographic examination is discussed under the subheading of Sample No. 7, and the defects are shown including the rivet failure in Figures 26 through 28 of Reference 5. Material was AISI 347 stainless steel. The baffle tube operated at temperature levels of 1500°F to 1600°F maximum, and the end plate operated at 1000°F to 1200°F maximum temperature, as determined in Reference 4.

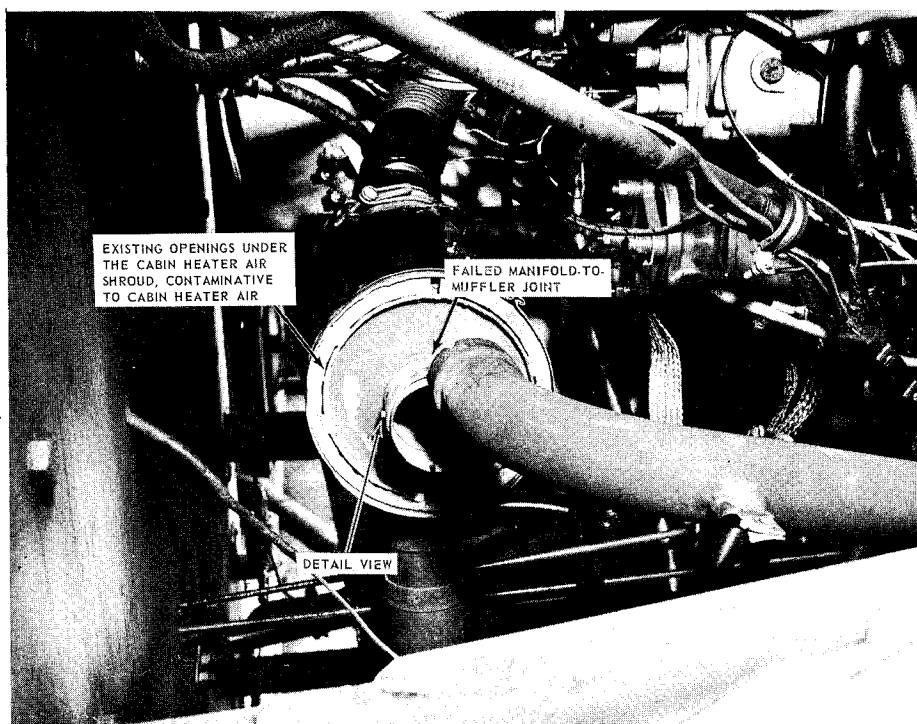
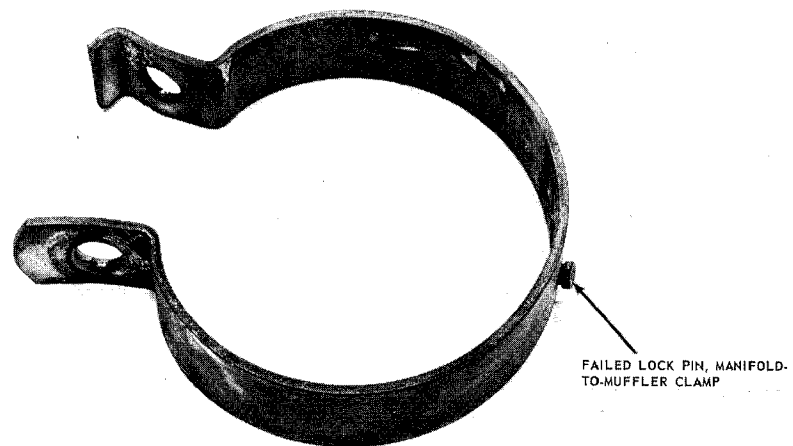
FIG. 1.10 FAILED MANIFOLD-TO-MUFFLER JOINT

Test Hours - 490: The clamp lock pin failed permitting the right manifold to separate from the muffler joint at 490 test hours. Exhaust gases were blasted through the existing openings under the cabin heater air shroud resulting in .065 percent carbon monoxide contamination of the cabin air. This malfunction is presented in Figures 1.10 and 1.11. Metal expansion with high-temperature exhaust gases may have influenced this failure. A number of similar failures has occurred in operating aircraft. The failure demonstrates and emphasizes that the cabin heaters must be designed and fabricated airtight or sealed to prevent outside contamination from entering the heaters upon occurrence of an unforeseen failure. A section of the muffler including the joint was analyzed metallurgically under the subheading of Sample No. 6, and depicted in Figures 24, 25, and 26 of Reference 5. The material is AISI 347 stainless steel .030 inch thick in the joint area and the baffle tube is .020 inch thick. Maximum operational temperature of the joint was 1000°F to 1200°F and the baffle tube operated at 1500°F to 1600°F maximum. (See Reference 4.)

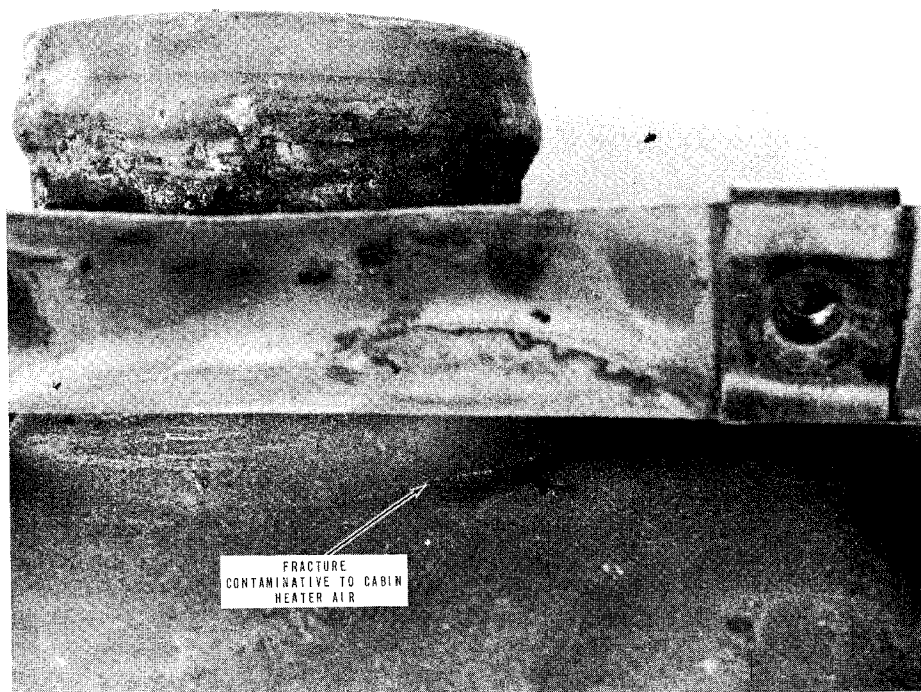
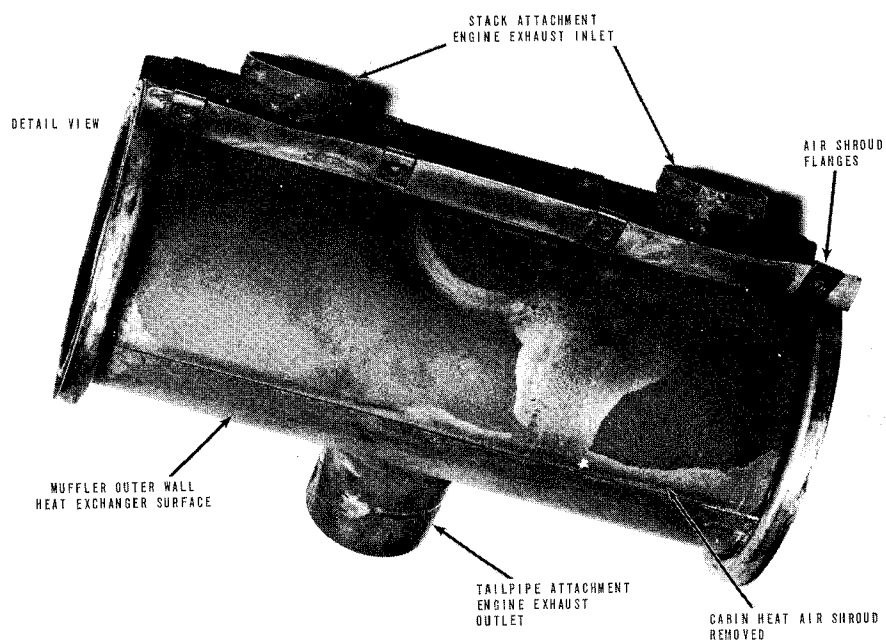
FIG. 1.12 FAILED CABIN HEAT EXCHANGER

Test Hours - 550: A crack developed in the muffler outer wall heat exchanger surface at 550 test hours and contaminated the cabin air with .012 percent carbon monoxide. The defect is shown in Figure 1.12. A long history of both identical failures and general failures of this type have occurred in operating aircraft. The crack occurred in the radius of the stack inlet attachment, an area of stress concentration.

The material was AISI 321 stainless steel .030 inch thick operating under metal temperatures of 1000°F and 1200°F maximum on the outer surface. The inner surface was in contact with exhaust gases at maximum temperatures of 1380°F to 1480°F. (See Reference 4.)

Metallurgical evaluation is discussed under the subheading of Sample No. 9, and photomicrographs are shown in Figures 37 through 40 of Reference 5. As stated, "The sample was heavily oxidized on both the inside and outside surfaces. The outside surface showed deeper penetration at various locations along the surface. It is considered significant that the oxidation corrosion penetrates in some areas in a sharp pointed manner, thus creating points of stress concentration from which fatigue cracks can originate. The structure around the crack contained sigma phase distributed discontinuously in the grain boundaries, and severe oxidation."
